# “Haggie Hints”

Issue 15, 2014

## ***A Unique Structural Upset on a Koepe Hoist Rope***

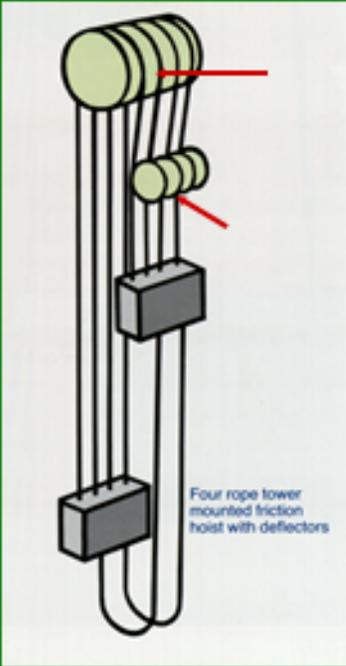
While it is possible for the entry angle to cause a rope to rotate in either direction, the most noticeable reaction is when the rotation causes the outer cover "lay" to lengthen. The upsets are located as shown on this slide.

- Unique structural upsets may occur when:-
  - The ropes are forced to "rotate" or "roll" into the drum or deflector sheave grooves*
  - This rotation causes severe changes in lay lengths.
  - Most severe is when rotation causes outer lay to lengthen and inner to shorten

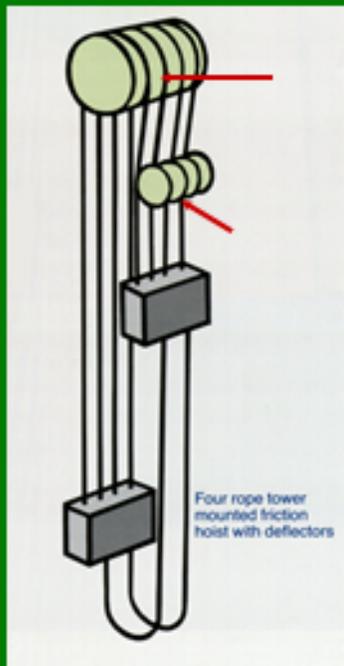
- *The ropes are forced to “rotate” or “roll” into the drum or deflector sheave grooves*
  - As inner lay shortens, it may rupture
  - This is commonly referred to as a “*Hernia*” rupture and is most common with FLC hoist ropes
  - Stranded ropes may exhibit dramatic lay changes.

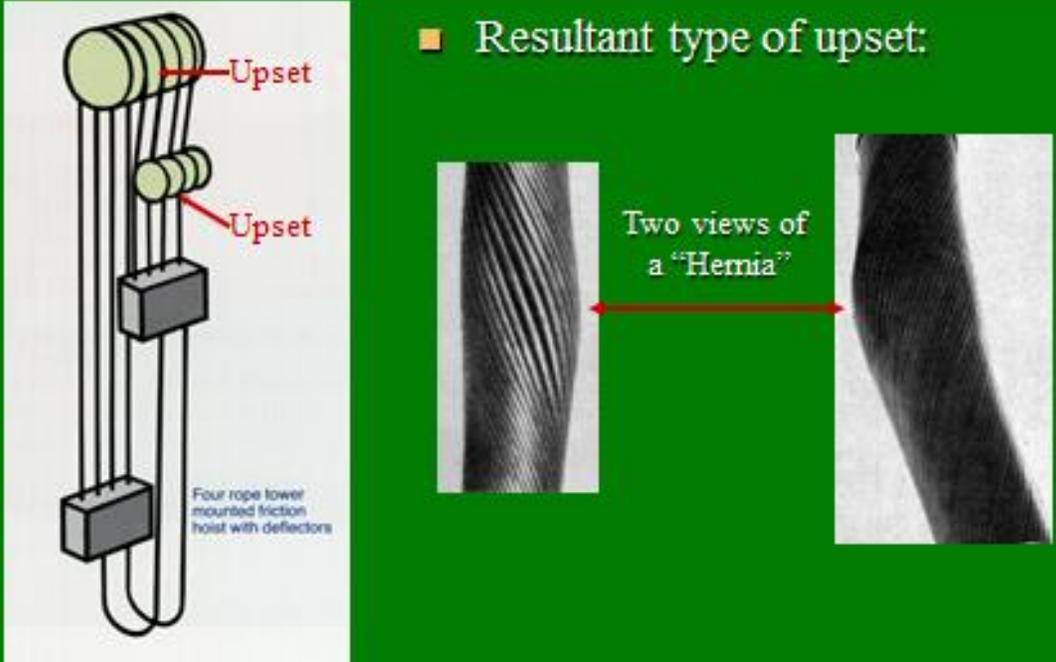
The slide below illustrates the external appearance of the hernia which appears to only be a swelling, or shows a relatively small increase in rope diameter.

The photos shown are those of a 1.515" diameter FLC so it can be seen that the upset is confined in length to 3 or 4 rope diameters.

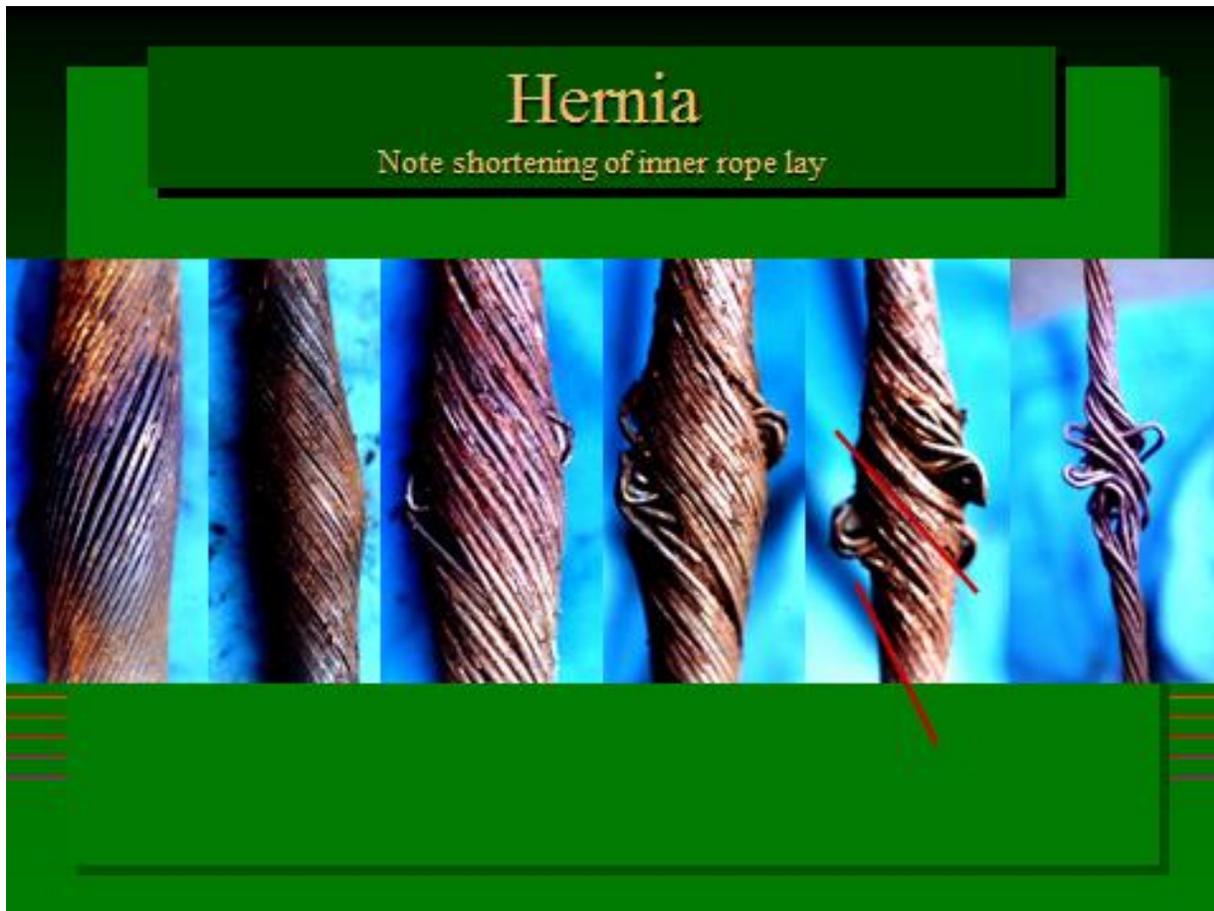
The next slide shows each layer as they are removed. The condition of the interior is fairly startling.

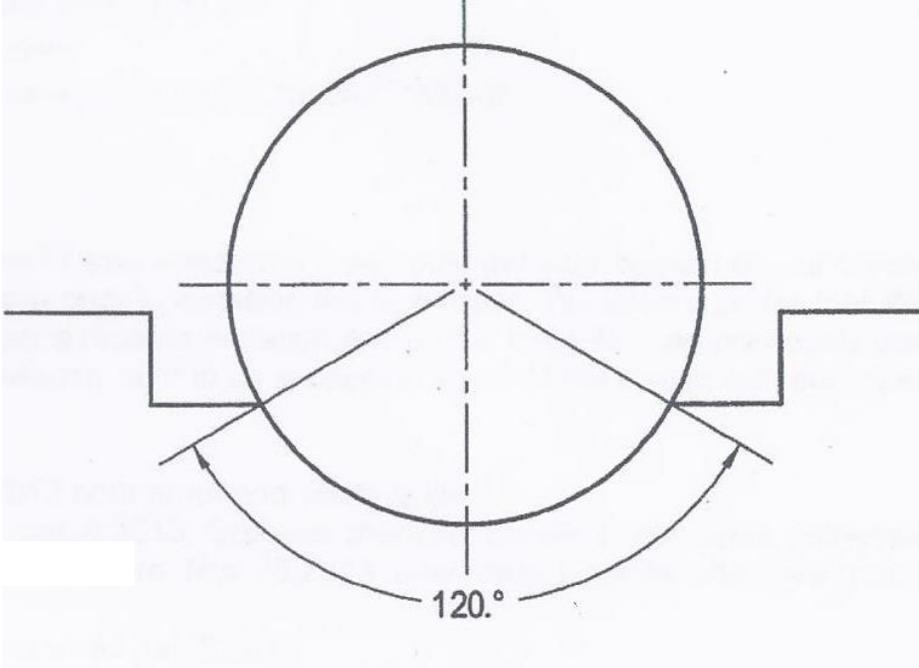
In addition, an entry angle can also exist due to rope whip so it is imperative that as the grooves in the drum or deflector sheave wear to approaching  $\frac{1}{2}$  of the rope diameter, the sides of the grooves be "relieved" to avoid contact and thus removing the possibility of the rope rolling into position.

Here is a diagram of the ideal groove profile:

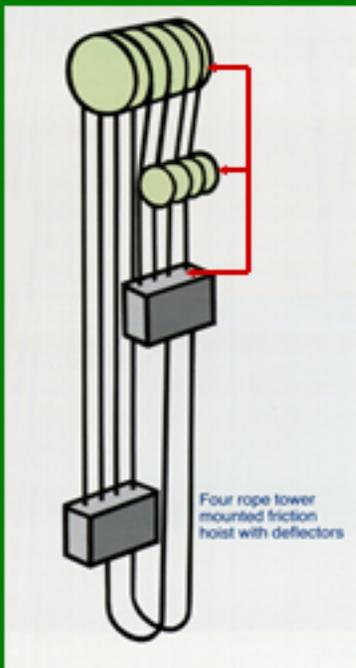
*The rope being forced to “rotate” into the drum or deflector sheave grooves – An angular deflection of  $0^{\circ}4'$  can cause the upset! The effect is greater when a high coefficient of friction exists*

## ■ CURE - Ensure rope enters the groove without interference

- If the grooves are worn  $> 1/2$  rope dia., then machine a relief angle
- Closely check rope to groove alignment between conveyance in uppermost position, the deflector sheave and the drum
- Verify hoist is level
